Demonstration of Remedial Techniques against
Radon in Houses on Florida Phosphate Lands

EPA 520/5-83-009
July 1983

**DEMONSTRATION OF
REMEDIAL TECHNIQUES AGAINST RADON
IN HOUSES ON FLORIDA PHOSPHATE LANDS**

Final Report

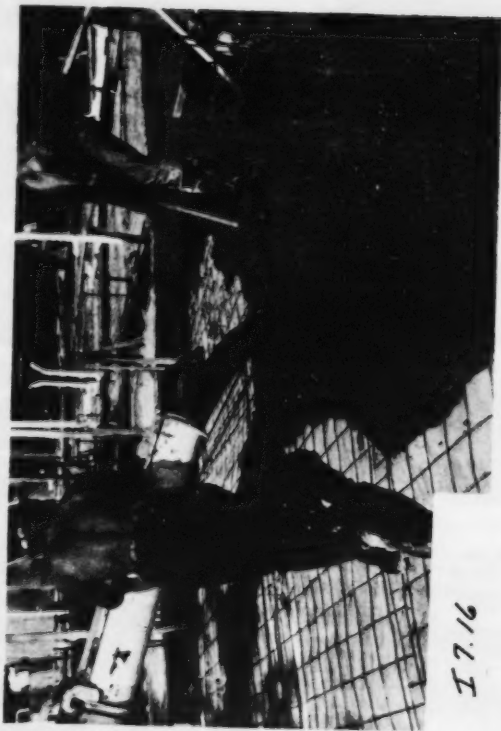
I 7.16

I-7.16	Placing concrete. Extra water was added to this mix to make it flow more readily. Note that there is no significant pile of concrete where the discharge strikes the ground.
I-5.8	Workmen levelling concrete. Note that they are standing in the concrete, on the mesh and plastic.
I-5.7	Reinforcing mesh trapped beneath concrete. Note the opening in the plastic around the water pipes.

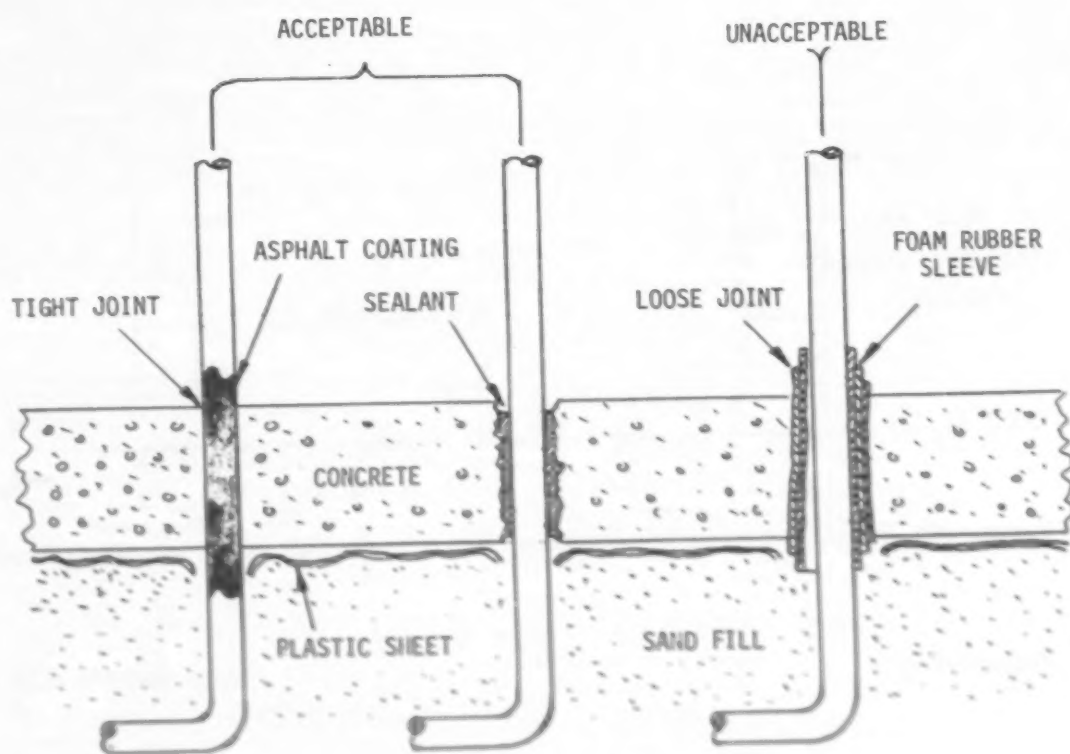
FIG. 3 PIPE ENTRIES

Water supply lines, and drain and vent lines are usually run beneath the floor slab, and brought up through the floor at the place they are required. A requirement of the Southern Standard Plumbing Code is that metal pipes passing through concrete must be protected against corrosion, and this is usually complied with by painting that portion of the pipe with asphalt, which gives an essentially airtight joint between the pipe and concrete. However, sometimes the protection is supplied by wrapping or sleeving the pipe with plastic or foam rubber sheeting, which is not airtight (Fig. 3). This practice would have to be specifically forbidden for radon resistant housing.

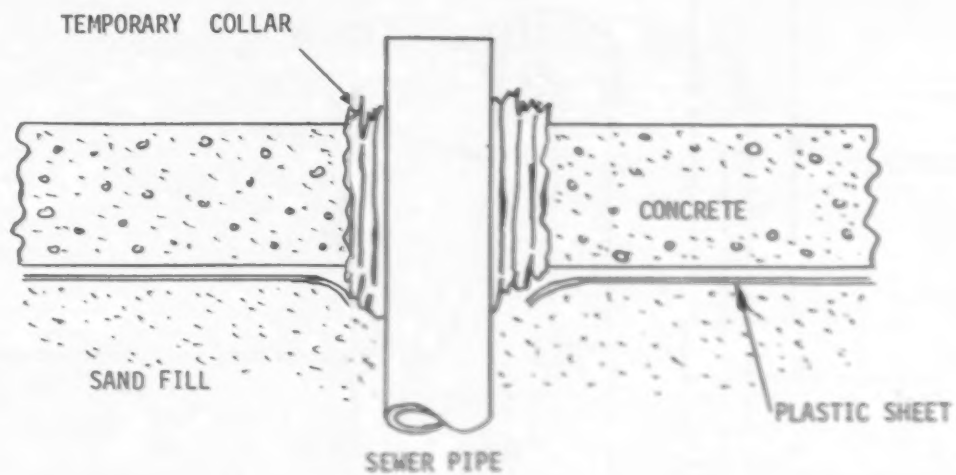
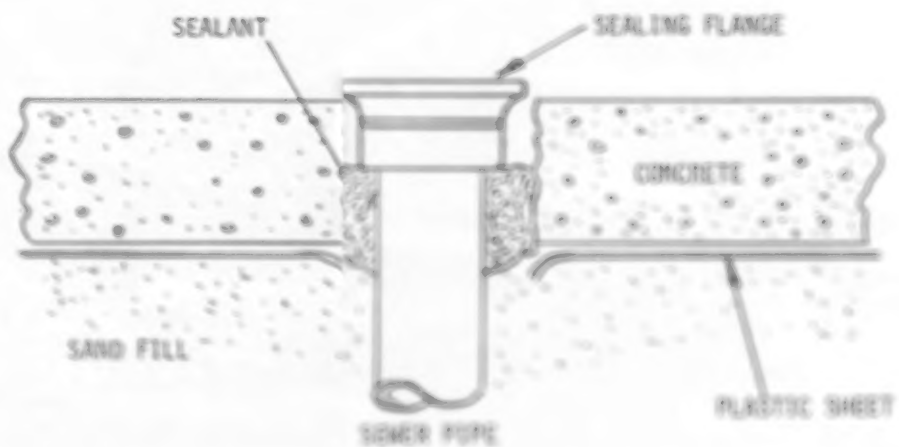
Floor mounted sanitary fixtures such as toilets and showers are drained by a pipe that terminates in a floor level flange to which the fixture is sealed. This flange has to be attached to the pipe after the concrete floor is poured, so the concrete is held away from the pipe by a collar of styrofoam or cardboard (Fig. 4A). When this temporary collar is removed, a hole is left clear through the slab into the fill. The hole is subsequently concealed by installation of the fixture. As the joint between the fixture and the floor is not airtight, this provides a major route for soil entry at every toilet and shower. This opening can be made airtight by filling the space between concrete and pipe with a sealant after the flange is attached (Fig. 4B).

4A SANITARY SERVICE ENTRY - CONSTRUCTION PHASE

4B SANITARY SERVICE ENTRY - SEALED

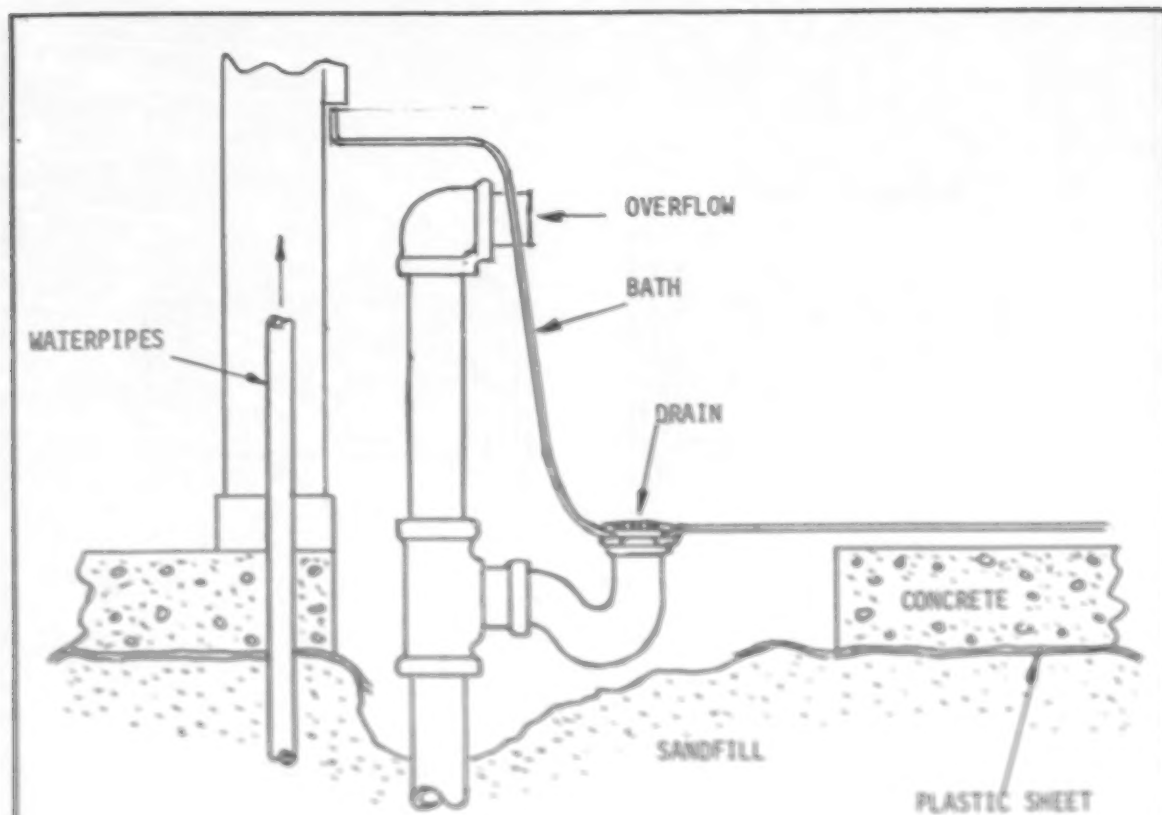
FIG. 5 BATH DRAIN INSTALLATION

Modern baths have the bottom of the bath just above the floor, and so the bath drain must be below floor level. The drain connection is generally 1 to 2 inches (2 to 5 cm) below the lower surface of the concrete slab. To provide access to this connection and space for the bath drain, it is usual to form an opening through the slab about 8 x 16 inches (20 x 40 cm) in size (Fig. 5). An opening of about this size is needed to provide access to the drain connection and give a little flexibility so that the bath can be positioned against the bathroom walls. The usual "form" is a concrete block, which is pulled out by the concrete finishers when the concrete sets. A wooden frame is occasionally used, and is often left in place.
